WINDFIELD HOUSE - Materials Analysis

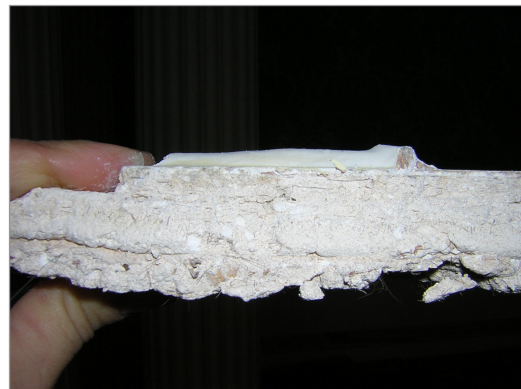
Following extensive re-plastering of the inside of this listed building, large areas of plasterwork had fallen away from the underlying lathe-work. The client requested the plaster to be analysed to establish whether it complied with the specified mix requirements.

Laboratory examination showed that the plaster ingredients and proportions complied with normal good practice. Failure of the plasterwork was considered more likely to be associated with the lathe-work design and pre-treatment, or as a result of non-conformance with specified plaster application procedures.

Area re-plastered and re-instated.
