CIRENCESTER MUSEUM – Mosaic

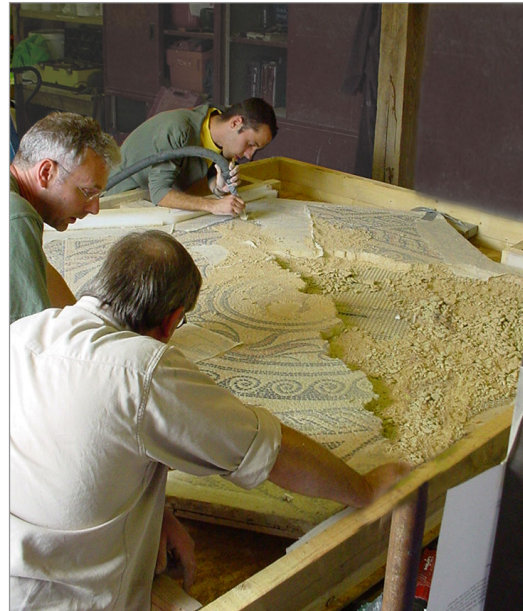
A protection scheme was devised and implemented that allowed 3 floor mosaics to remain in situ whilst the building was demolished and rebuilt around them.

The mosaic panels were lifted from the floor and re-backed onto a lightweight Hexlite board using a reversible sand and Paraloid mix, with expanding polyurethane foam for levelling, as developed by the British Museum

Some of the panels were re-backed on a new plywood structure with a stainless steel frame bolted to the back to enable it to be hung in the museum
