## HOLLIS & ANTHONY TOMB – Church Monument

### Challenge

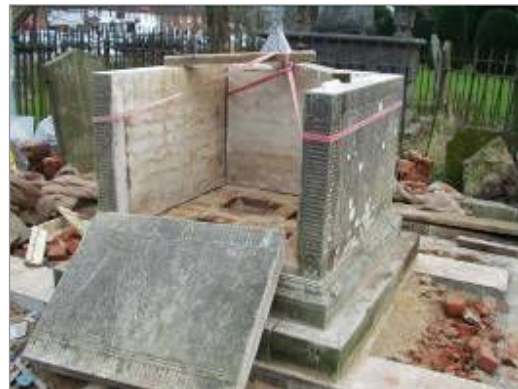
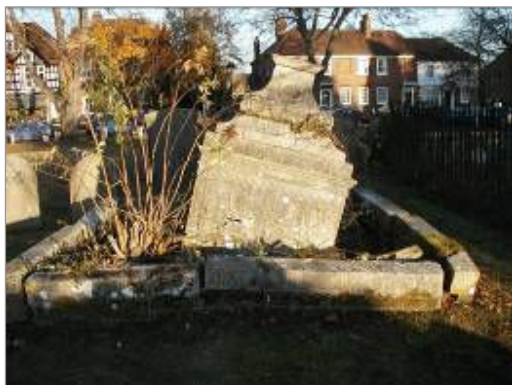
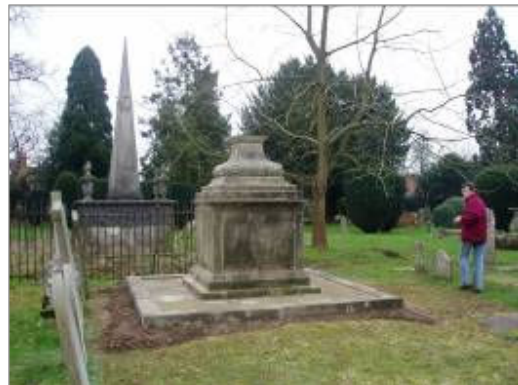
One of five listed tombs in the churchyard of St Mary's Church, Beaconsfield. The large square profiled tomb consists of inscribed panels to all sides with a brick core surmounted by a raised capstone. All had collapsed into the vault below.

The sections were recorded, dismantled and put aside for re-assembly. A concrete H beam was designed and constructed to bridge the double vault and the tomb was re-erected in its original position. It then received a light conservation clean.
